ANNUAL REPORT FOR 2009

**Mile Branch
Guilford County
TIP No. R-0609IA**

Prepared By:
Natural Environment Unit & Roadside Environmental Unit
North Carolina Department of Transportation
October 2009

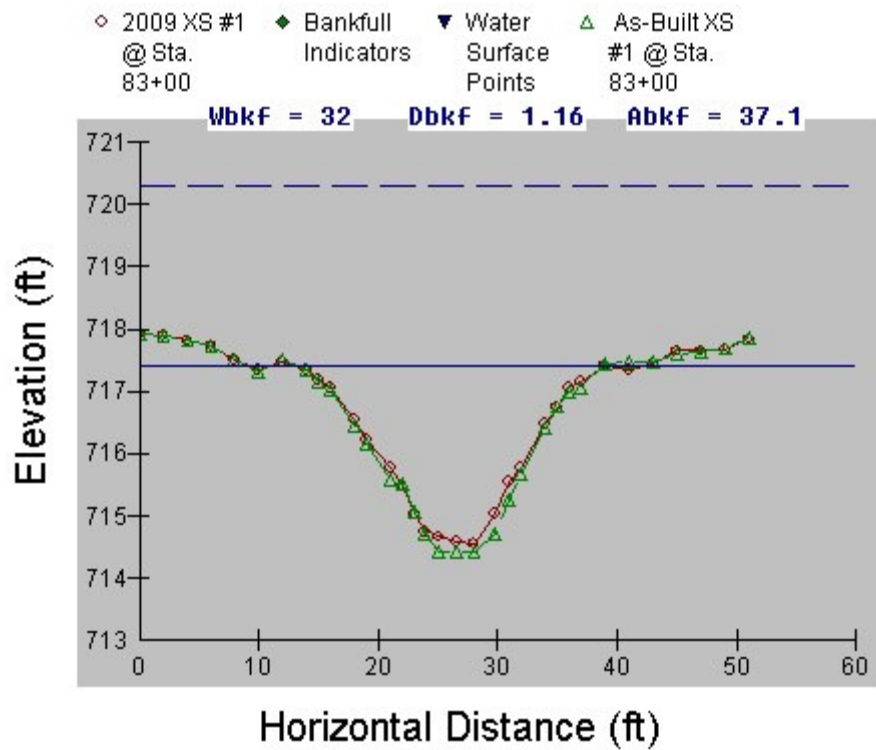
Riffle Cross Section #1 @ Sta. 83+00

Cross-Section #1 (Riffle) Abbreviated Morphological Summary					
	2009	2010	2011	2012	2013
Bankfull Width (ft)	26.3				
Bankfull Mean Depth (ft)	1.4				
Width/Depth Ratio	18.8				
Bankfull Cross Sectional Area (ft ²)	36.9				
Maximum Bankfull Depth (ft)	2.86				
Width of the Floodprone Area (ft)	51				
Entrenchment Ratio	1.94

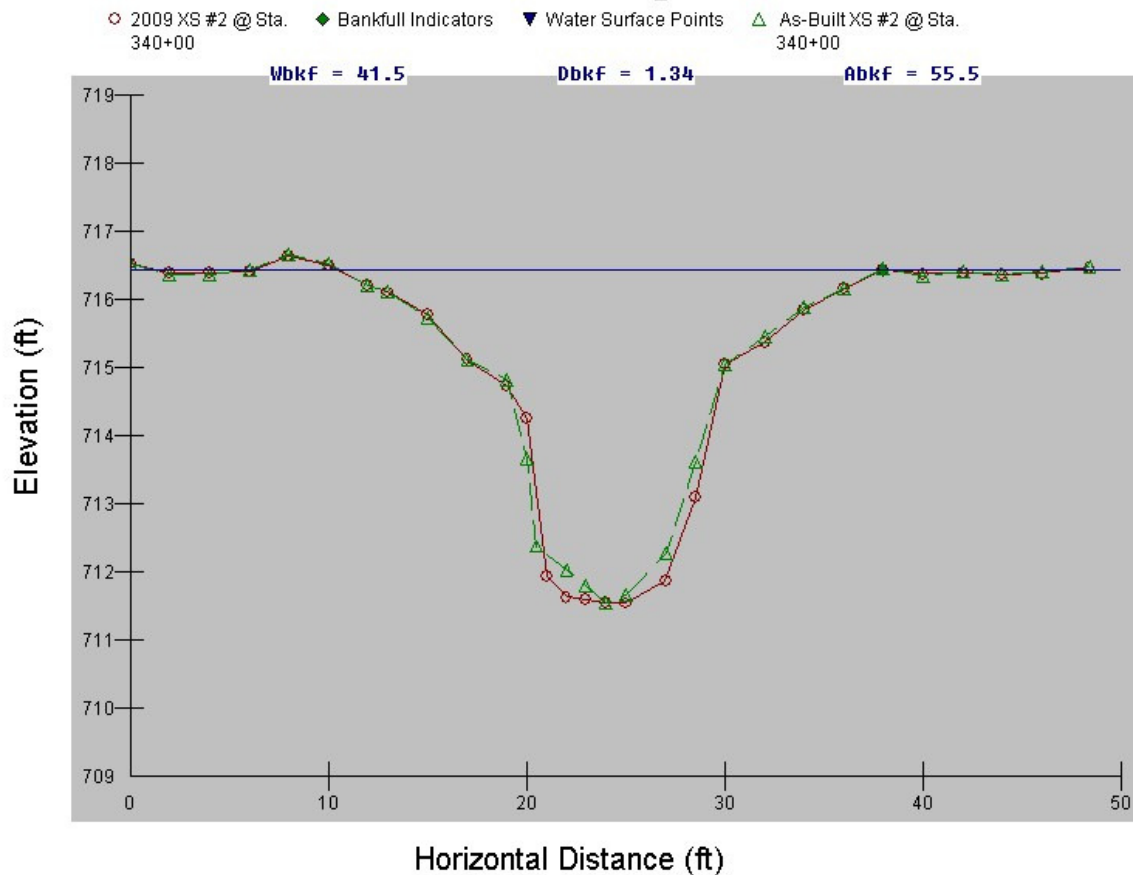
Pool Cross Section #2 @ Sta. 340+00

Cross-Section #2 (Pool) Abbreviated Morphological Summary*					
	2009	2010	2011	2012	2013
Bankfull Cross Sectional Area (ft ²)	55				
Maximum Bankfull Depth (ft)	4.89				
Bankfull Mean Depth (ft)	2				
Bankfull Width (ft)	27.52

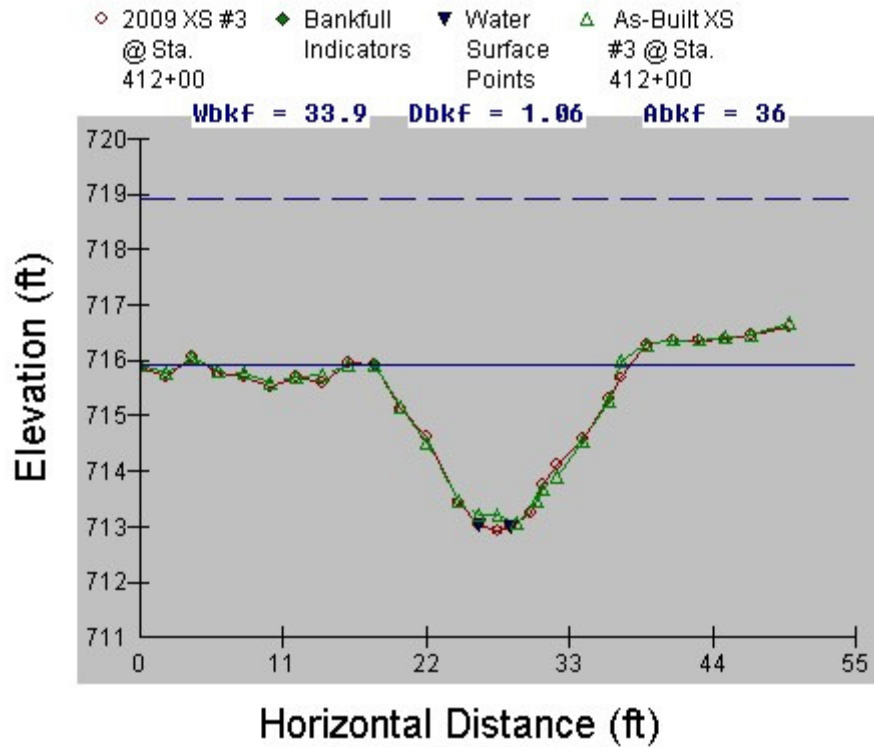
Riffle Cross Section #3 @ Sta. 412+00

Cross-Section #3 (Riffle) Abbreviated Morphological Summary					
	2009	2010	2011	2012	2013
Bankfull Width (ft)	19.75				
Bankfull Mean Depth (ft)	1.68				
Width/Depth Ratio	11.76				
Bankfull Cross Sectional Area (ft ²)	33.15				
Maximum Bankfull Depth (ft)	3				
Width of the Floodprone Area (ft)	49.9				
Entrenchment Ratio	2.53

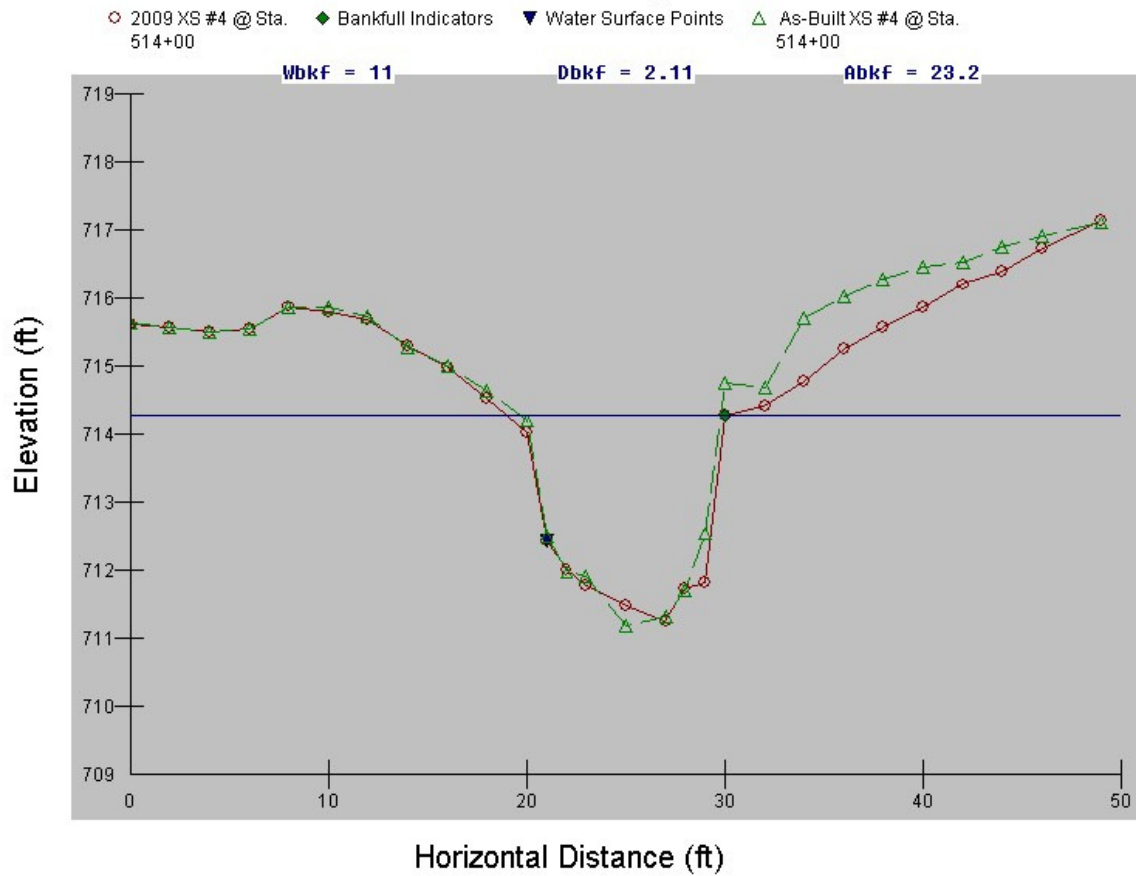
Pool Cross Section #4 @ Sta. 514+00

Based on comparisons of the as-built to 2009 monitoring data, all four cross sections appear stable with little or no active bank erosion. The floodplain on the right bank at Cross Section #4 had to be repaired after the as-built was completed and the right endpin at this cross section had to be reset. The graph of Cross Section #4 shows this layout. Graphs of the cross sections are presented in Appendix A. Future survey data will vary depending on actual location of rod placement and alignment; however this information should remain similar in appearance. The longitudinal profile shows that the channel is stable for the 2009 monitoring evaluation. There were no water surface shots taken from Sta. 0+00 to Sta. 140+00 due to the lack of flow in the channel. Water was also not flowing within both tributaries during the monitoring assessment.

Cross-Section #4 (Pool) Abbreviated Morphological Summary*					
	2009	2010	2011	2012	2013
Bankfull Cross Sectional Area (ft ²)	23.18				
Maximum Bankfull Depth (ft)	3.02				
Bankfull Mean Depth (ft)	2.11				
Bankfull Width (ft)	11
